Innovated Friction Coating Process

By Takeshi SHIONODA*

Abstract

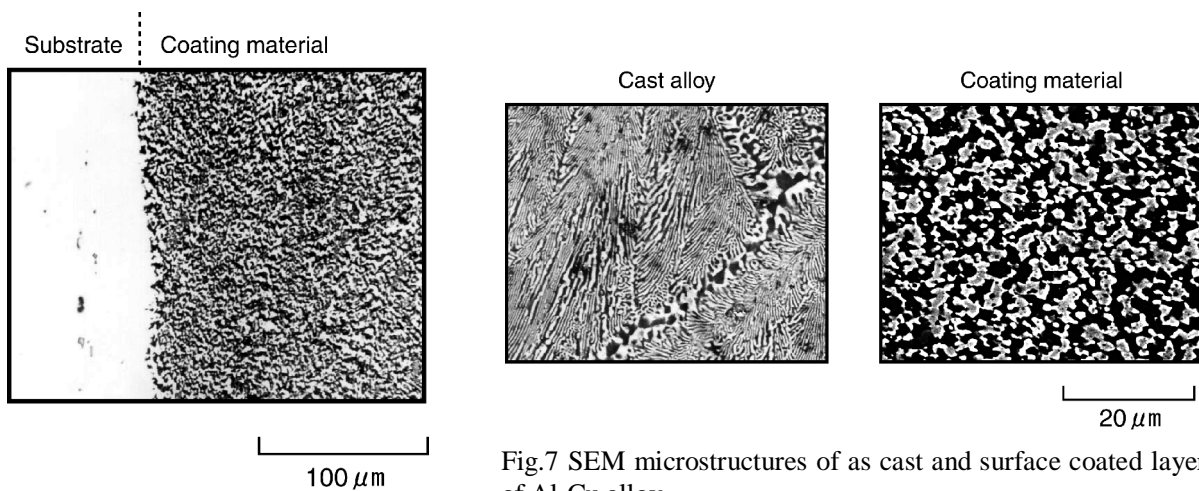
Figure 6 shows the microstructure of interface of surface coated layer with Al-Cu35% alloy for 25mm diameter bore. Careful observation indicates perfect-defect free interfaces and modified coating layers. The surface of the coated layer was quite smooth in appearance under all operating conditions. The microstructures observed optically and by using SEM indicate that the original eutectic cast structure has transformed into a uniformly distributed and refined form. Figure 7 shows SEM microstructures of the as cast and as processed coating material.

Fig.6 Microstructure of coating with Al-Cu35%

Fig.7 SEM microstructures of as cast and surface coated layer of Al-Cu alloy

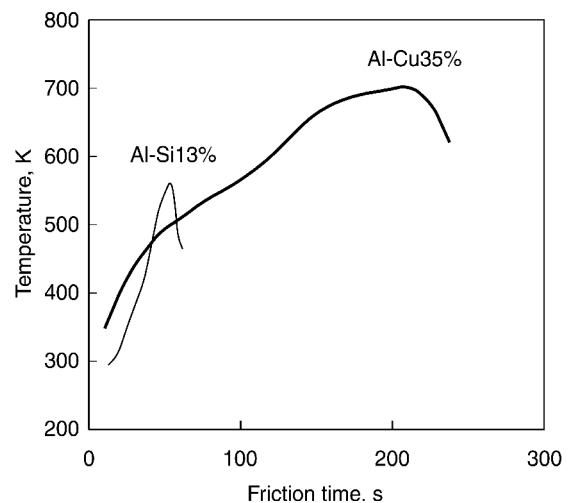
Figure 9 shows the difference in thermal cycles for coating of Al-Cu35% and Al-Si13% alloys. The heating rate for the Al-Si13% alloy is faster than that of the Al-Cu35% alloy. Al-Si13% undergoes plastic deformation quickly and hence frictional heat input rate is faster leading to an increased heating rate. Due to its high hardness, Al-Cu35% alloy needs the longer time for plastic deformation, thereby leading to slower heating rate. An increased time for plastic deformation also causes more frictional heat input, which leads to higher maximum temperature as compared to those achieved during coating of Al-Si13% alloy. The respective maximum temperatures reached during coating of Al-Cu35% and Al-Si13% alloys are 735K and 648K respectively.

Fig.9 Effect of coating composition on thermal

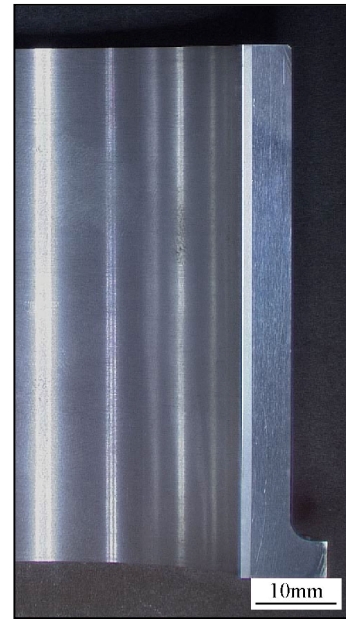
Figure 10 shows the cross section of coated cylinder with 80mm diameter. The material of cylinder was A5056, and coating layer was Al-25%Si. The thickness of coating layer was uniform and thin. The novel surfacing process can applied to large diameter cylinder without serious problem, and obtained the suitable coated layer.

Fig.10 Cross section of coated cylinder with 80mm diameter

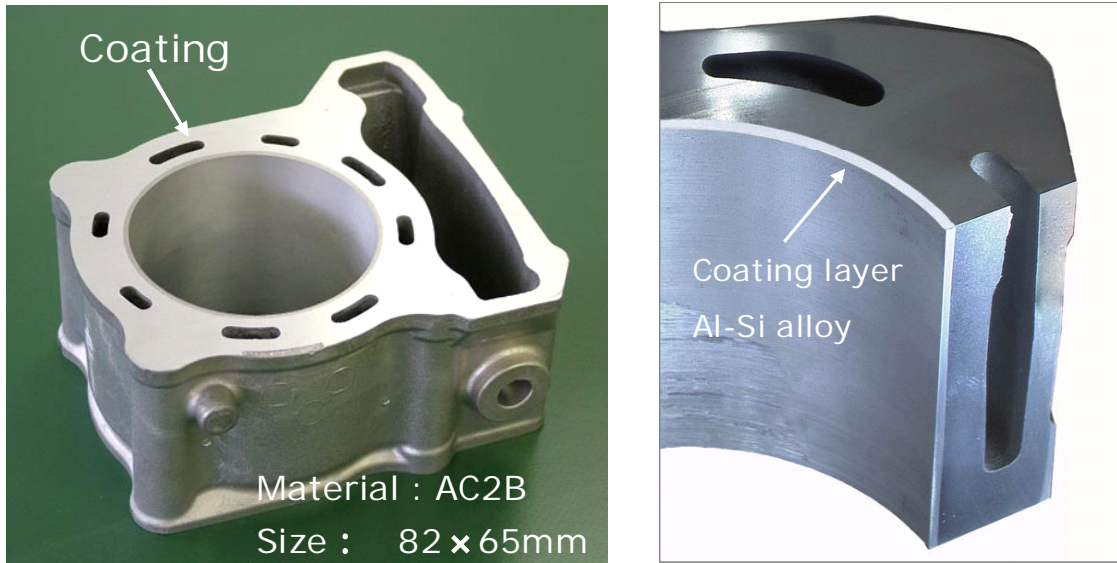
As described above, it was shown that the developed inner coating process could coat the large diameter cylinder and coated layer was sound without defect. Coating was tried to the actual engine cylinder block that is the target of this process from those results. Coating was carried out to the single cylinder aluminum engine block which is practical productions. Material of the block was AC2B cast aluminum alloy and the cylinder was 82mm diameter. A thickness of cylinder is asymmetry due to water jacket in side of cylinder. Therefore, the strength of cylinder was uneven in same level of cylinder during duration of coating. This caused the deformation of cylinder, and produced defects. However, as shown in figure 16, it was found that the thickness of coated layer was uniform.

Fig.16 Cross sections of coated aluminum cast engine block
